## DIFFERENCES IN TOOTH DISCOLORATION BETWEEN ZINC OXIDE EUGENOL AND MINERAL TRIOXIDE AGGREGATE-BASED SEALERS (LITERATURE STUDY)

### Dentistry

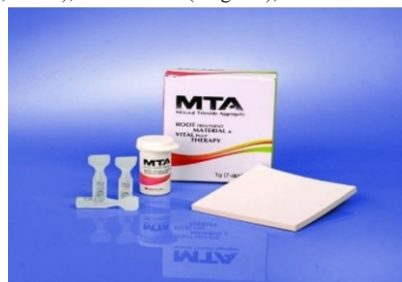
Figure 3. Mineral Trioxide Aggregate<sup>17</sup>

The most recent innovation in sealers is the calcium silicate / MTA-based material, and this material exhibits strong, biocompatible properties due to its high pH and ability to form hydroxyapatite<sup>16</sup>. MTA is a form of the main compound, Portland cement (PC). These new types of bioceramic sealers are ProRoot Endo sealers (Dentsply Maillefer, Ballaigues, Switzerland), MTA Fillapex (Angelus, Londrina, Brazil), MTA Obtura (Angelus), and others.<sup>12</sup>

MTA has the potential to be a multifunctional material, namely pulp capping, pulpotomy, apexification, root perforation repair (surgical and non-surgical), sealer, and root canal filling. During endodontic treatment of primary and permanent teeth, MTA can be used in various ways, for instance, as an apical and furcation restorative material and as a medicament for treating apexogenesis and apexification, repair of resorbing lesions and as retrograde obturation<sup>16</sup>. The advantages of MTA are that it contains hydrophilic particles and good sealing ability, is biocompatible, and has anti-bacterial and anti-fungal effects. This material has a good sealing ability compared to conventional materials used in root canal treatment. MTA, when used as a root MTA canal obturator, has physicochemical properties that can provide good results as a root canal obturator. MTA has disadvantage, including, long setting time, discoloration, and can affect aesthetic value.<sup>18,19</sup>
